Modifications to the Kwajalein BSRN Site December 2004

<u>D.W Nelson¹</u>, E.G. Dutton, and J. Wendell

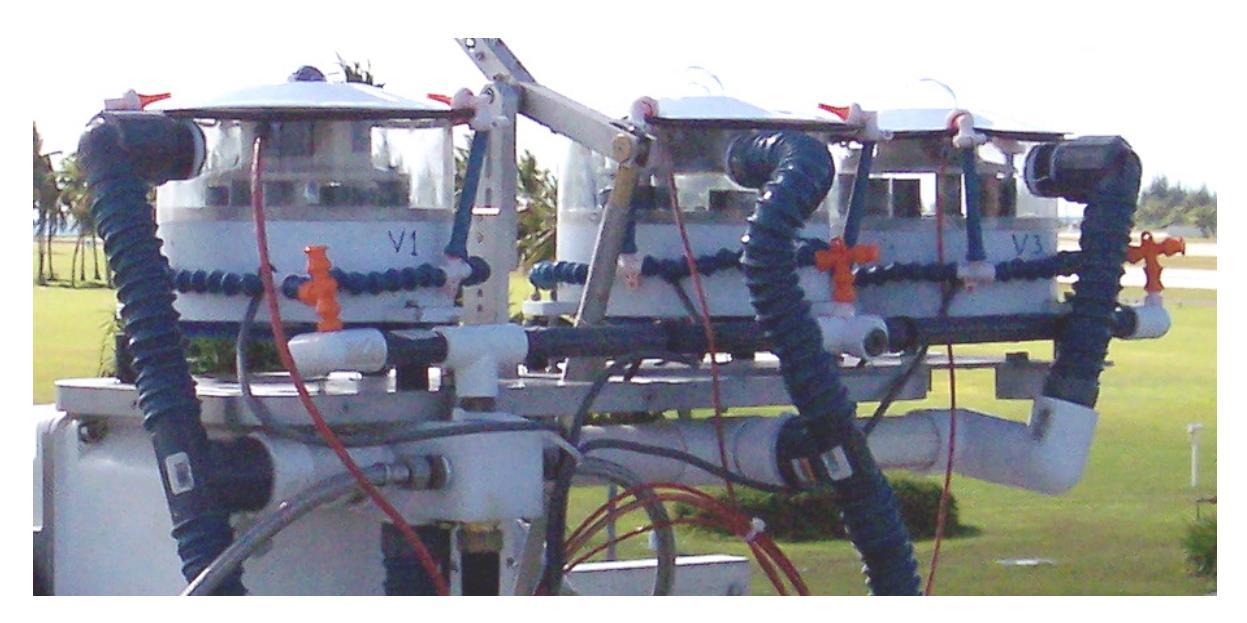
Figure 1. The modified ventilator housings and air manifold components installed during December 2004 at the Kwajalein BSRN site.
